**Re: Assessment for Community Development Services Center, 535 J Street, City of Los Banos, CA**

Subject: **Final Investigation Report**  
**Police Annex/Community Development Services Center**  
535 J Street  
Los Banos, CA  
Point 2 Job # 2023-108

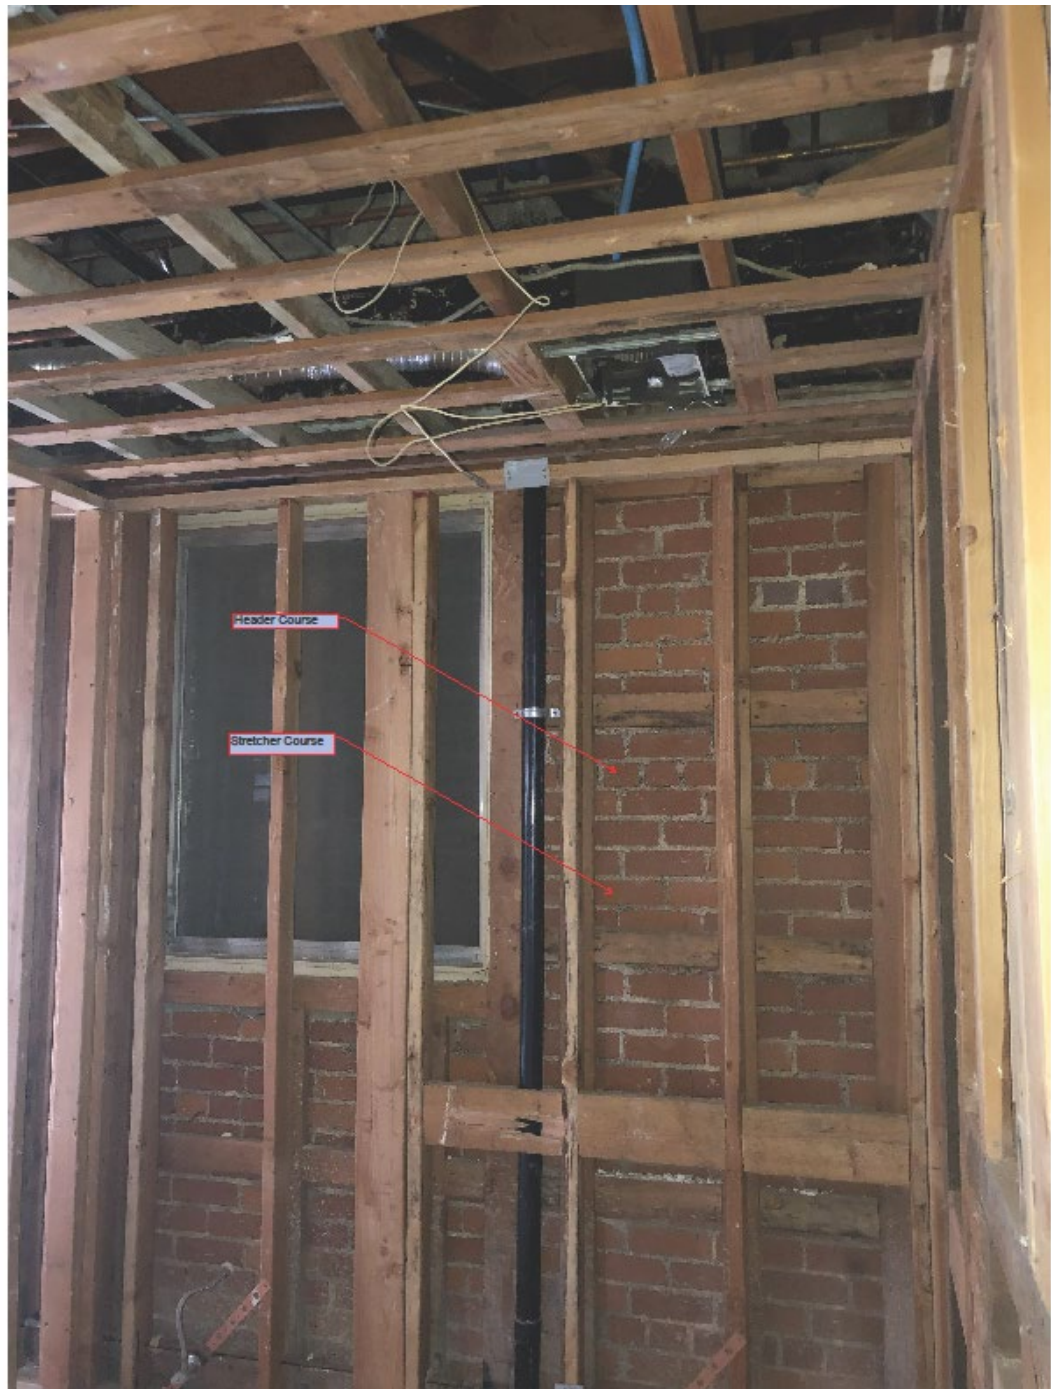
The 2 wythes of brick do not appear to have any reinforcement.

The heavy mass of an URM building will develop greater forces from an earthquake due to its inertia. Because of this and the multiple brick components not adequately anchored, a falling hazard exists from individual bricks becoming dislodged in a seismic event. These can cause severe injury or damage.

- URM strengthening with reinforced shotcrete constructed against existing URM walls on at least 4 exterior sides of the building.
  - New or augmented foundations under new shotcrete walls.
