AD01.3 Assessment for Community Development Services -  
535 J Street, Los Banos

**Re: Assessment for Community Development Services Center, 535 J Street, City of Los Banos, CA**

Subject: **Final Investigation Report**  
**Police Annex/Community Development Services Center**  
535 J Street  
Los Banos, CA  
Point 2 Job # 2023-108

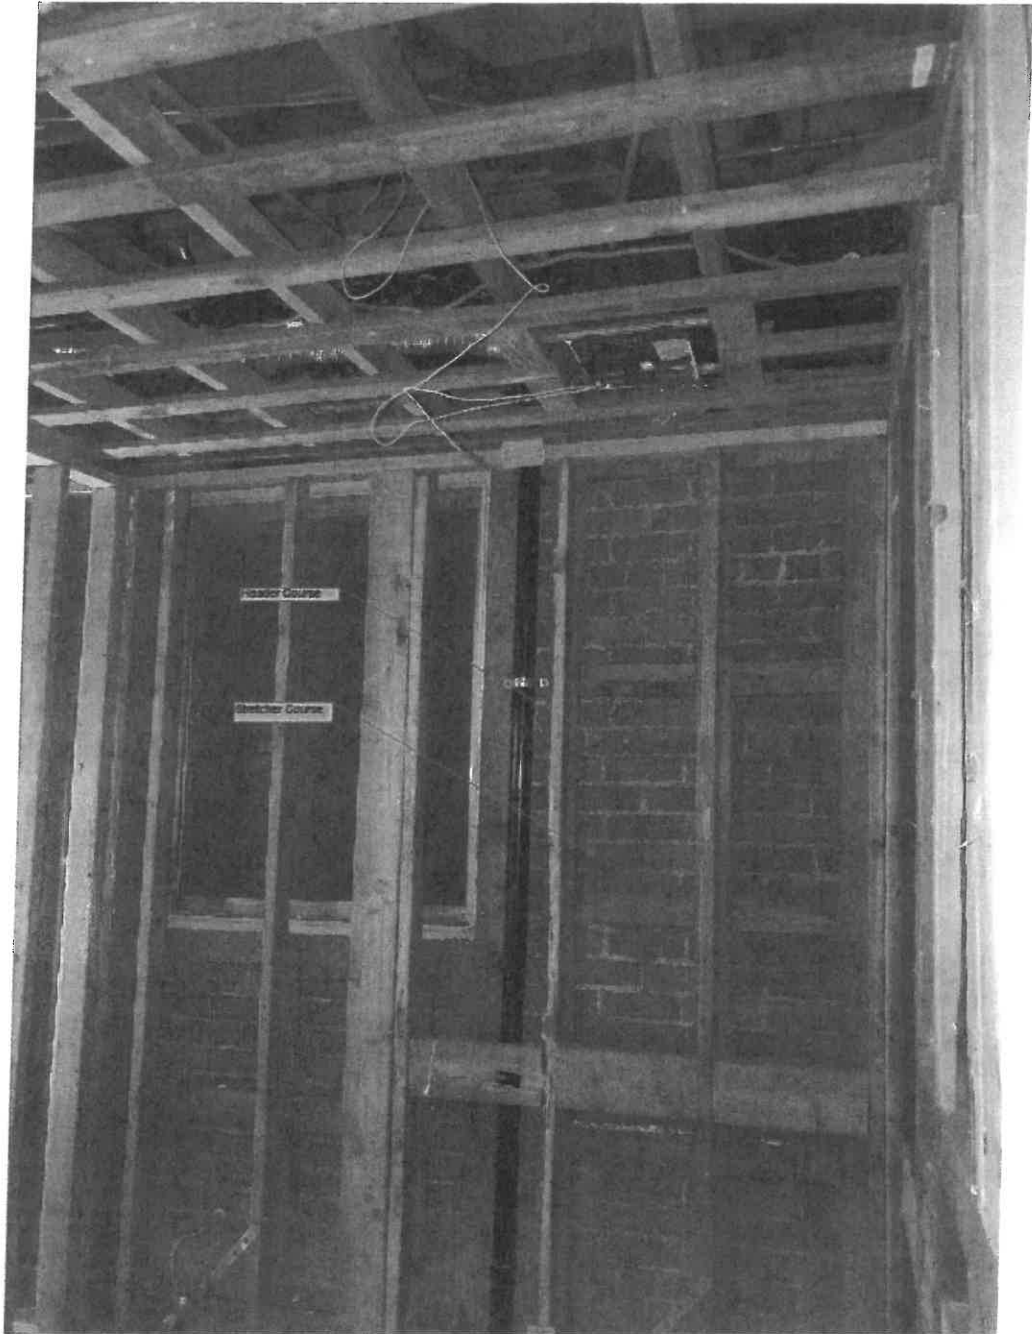
The 2 wythes of brick do not appear to have any reinforcement.

The heavy mass of an URM building will develop greater forces from an earthquake due to its inertia. Because of this and the multiple brick components not adequately anchored, a falling hazard exists from individual bricks becoming dislodged in a seismic event. These can cause severe injury or damage.

- URM strengthening with reinforced shotcrete constructed against existing URM walls on at least 4 exterior sides of the building.
  - New or augmented foundations under new shotcrete walls.

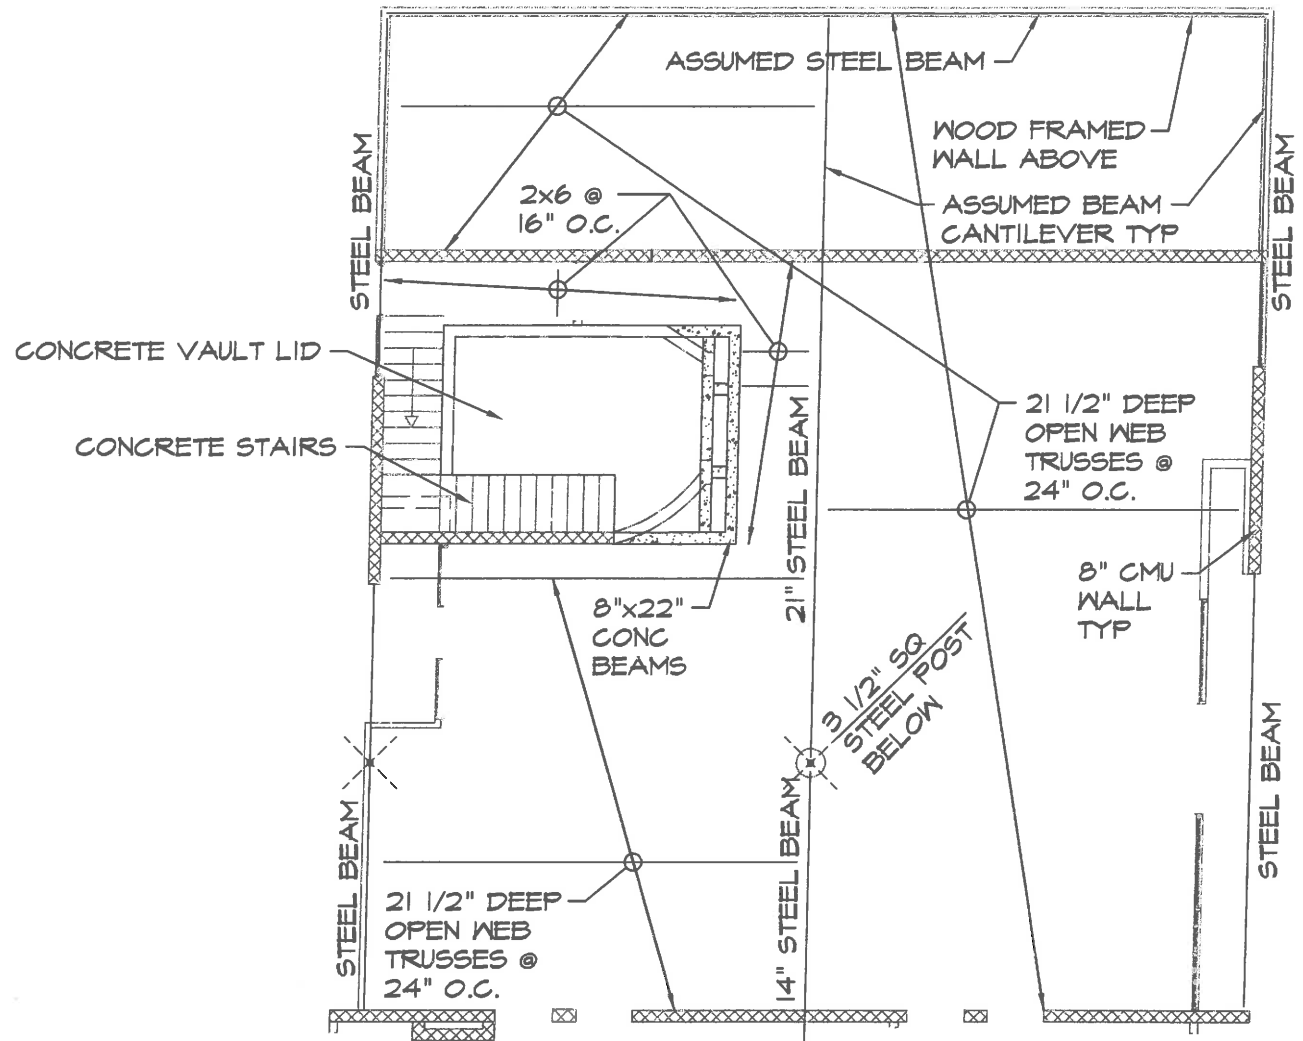
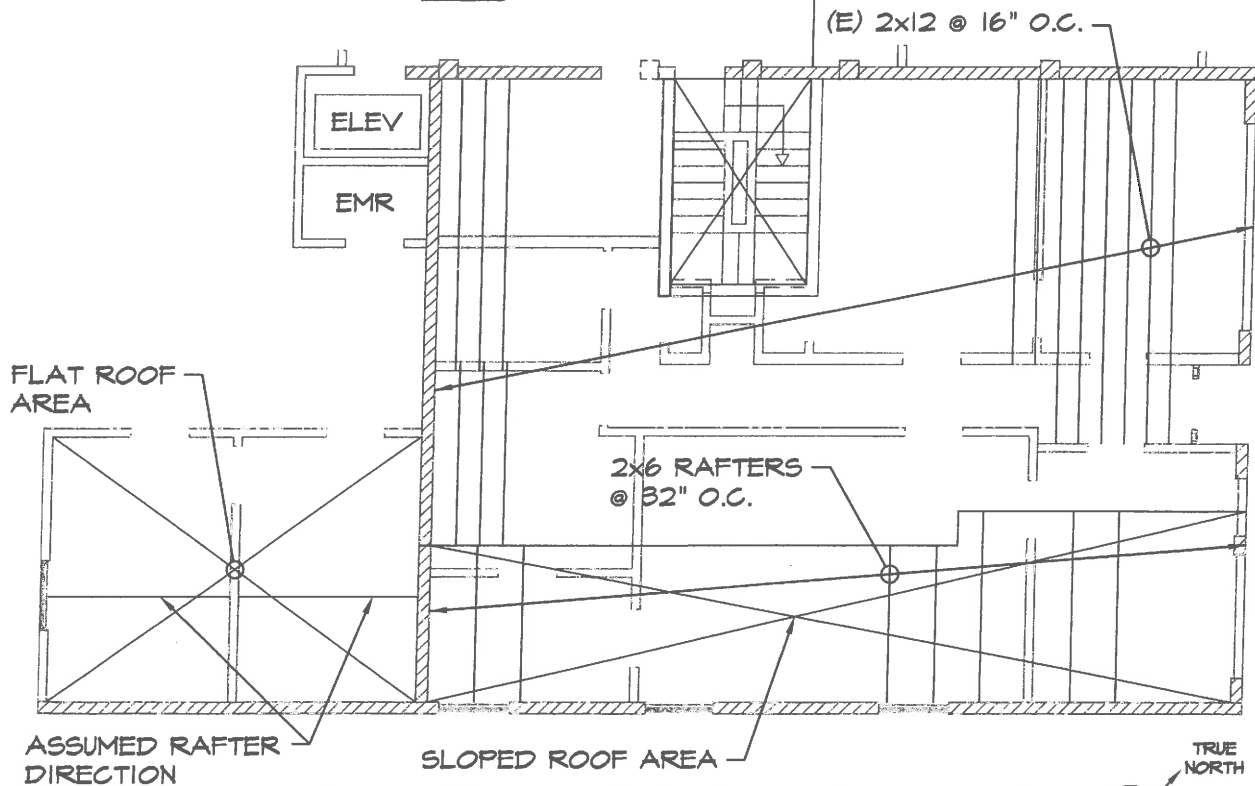
2ND FLOOR FRAMING PLAN

Please find attached preliminary framing plans indicating the structural members observed during the course of our site visit.
